Moisture Testing Report

12345 ABC Court

Minnetonka MN 55345

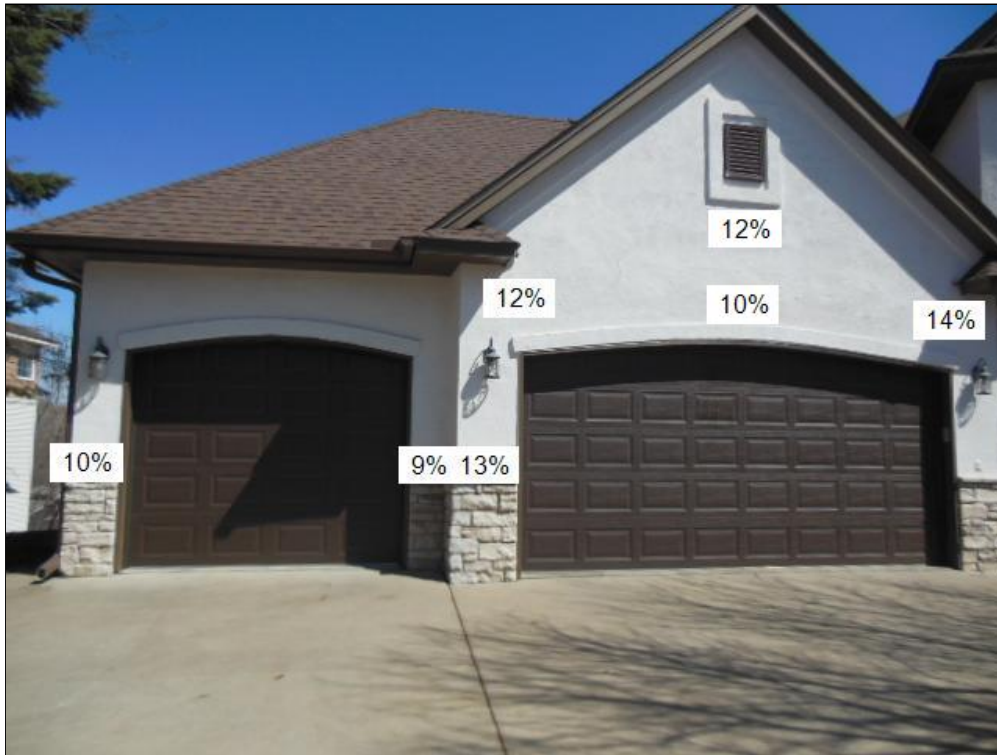
2.0 Elevation

(1) There were no elevated moisture readings, and the wall sheathing was firm at all of the areas tested below.

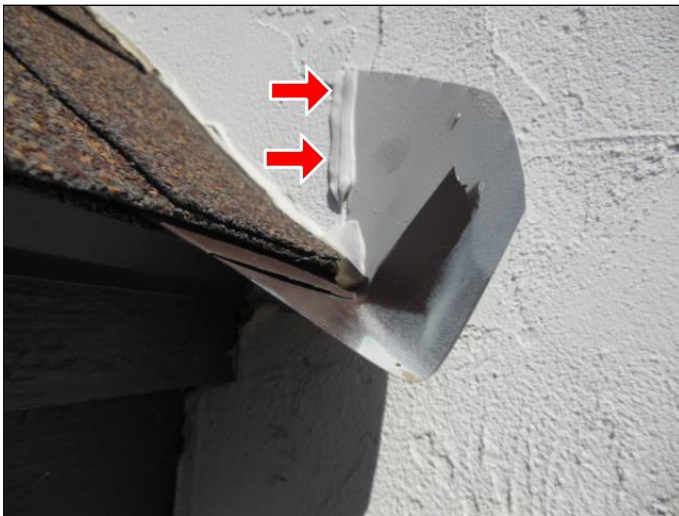
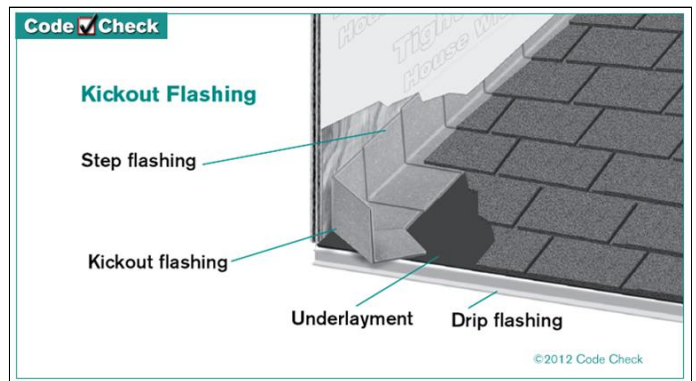
(2) Some kickout flashings were installed improperly and have the potential to allow for moisture intrusion. Have them properly re-installed.

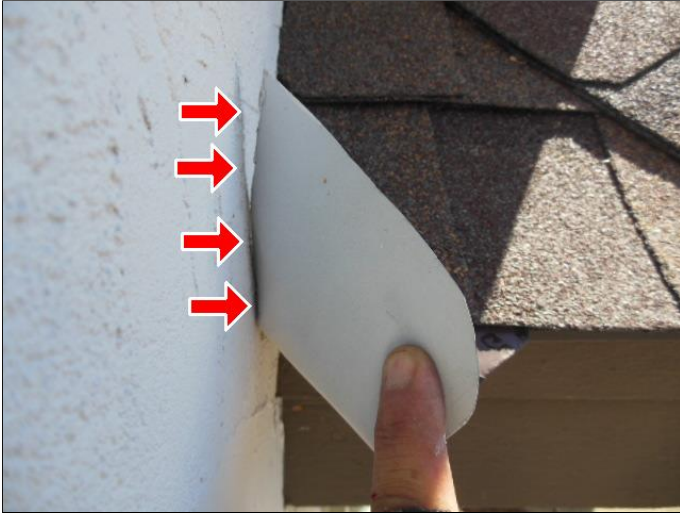
(3) Some kickout flashings were installed improperly and have the potential to allow for moisture intrusion. Have them properly re-installed.

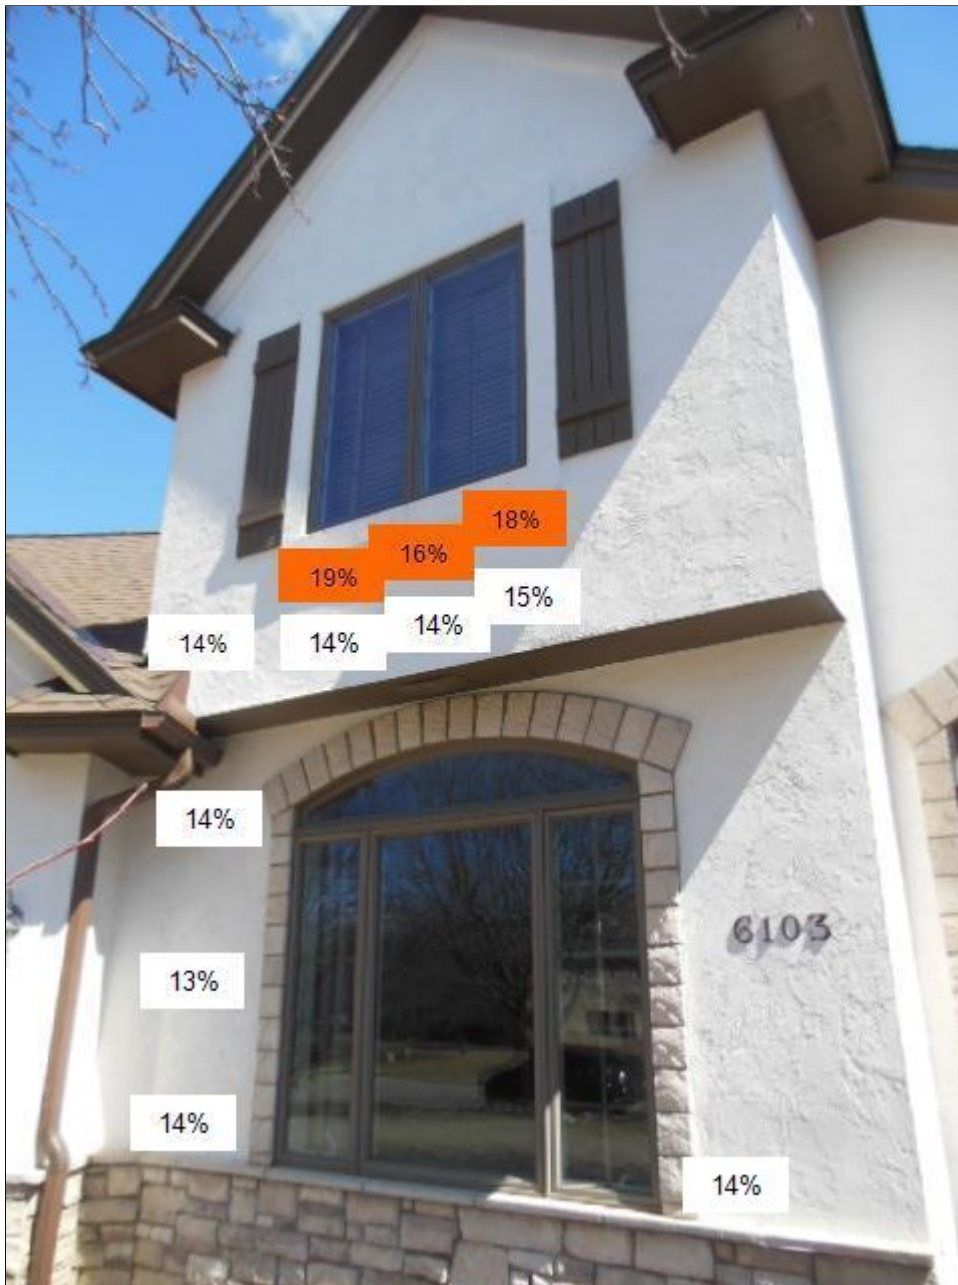
2.1 Elevation

(1) The moisture readings in orange were between 16% and 19%, which indicates elevated moisture readings but without signs of structural damage. The cause of the elevated moisture levels should be identified and corrected. The moisture intrusion may possibly be corrected by caulking, sealing, or adding missing flashings. Have the affected areas re-tested within six months to one year.

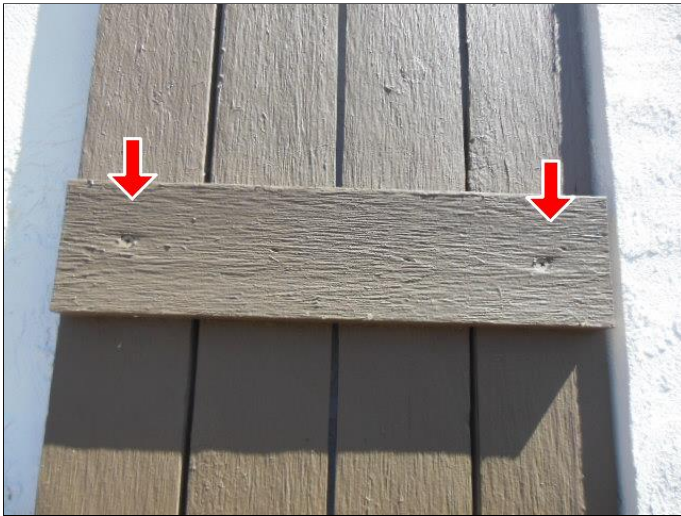
(2) The shutters are installed in an unsatisfactory manner by screwing through the shutters into the stucco. The installation of the shutters should be modified to provide better protection from possible moisture intrusion. Clip-on brackets are a better option; these brackets attach to the stucco cladding, are sealed, and then the shutter is snapped on.

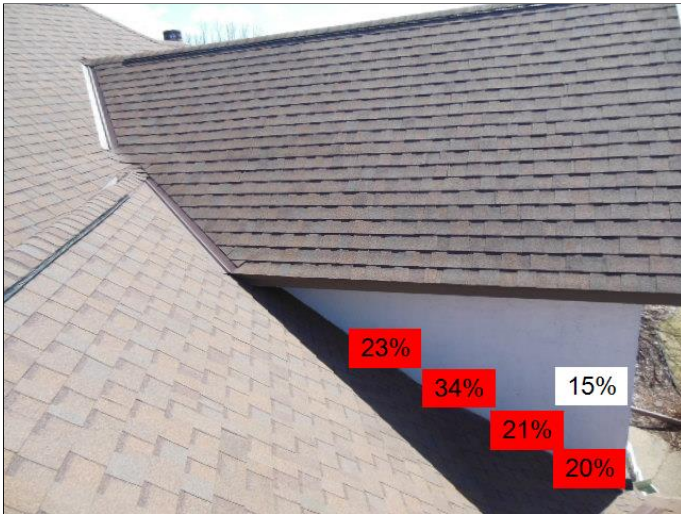
(3) The moisture readings in red were at 20% or higher indicating active leaking and possible structural damage.

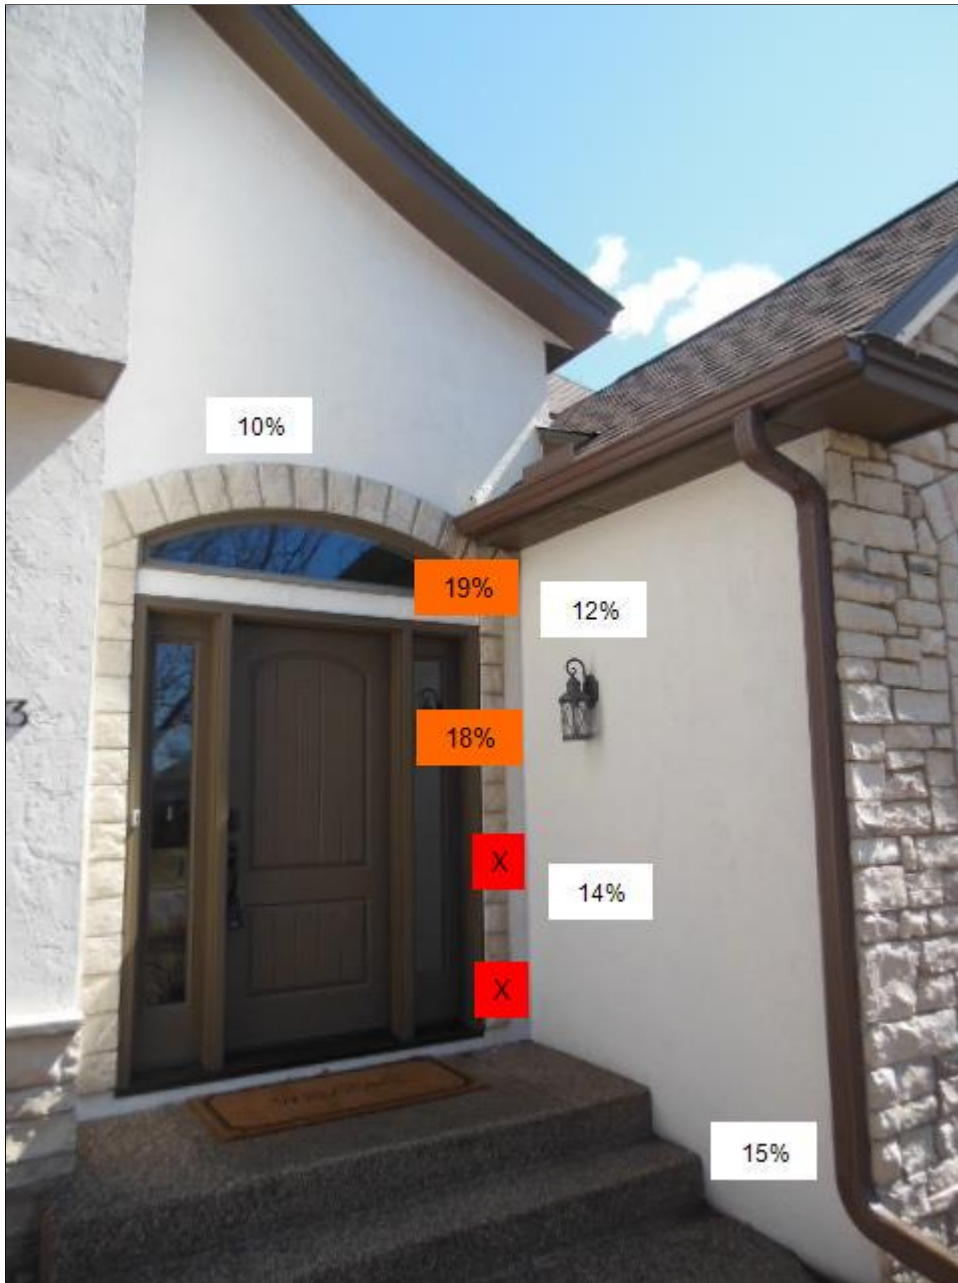
2.2 Elevation

(1) No sheathing detected or too soft to detect on red X area. This is considered wood rot. Investigate further. The moisture readings in orange were between 16% and 19%, which indicates elevated moisture readings but without signs of structural damage. The cause of the elevated moisture levels should be identified and corrected. The moisture intrusion may possibly be corrected by caulking, sealing, or adding missing flashings. Have the affected areas re-tested within six months to one year.

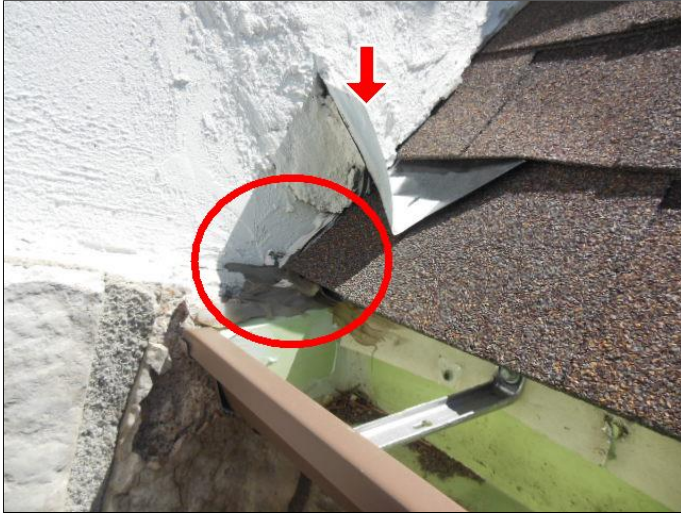
(2) Some kickout flashings were installed improperly and have the potential to allow for moisture intrusion. Have them properly re-installed.

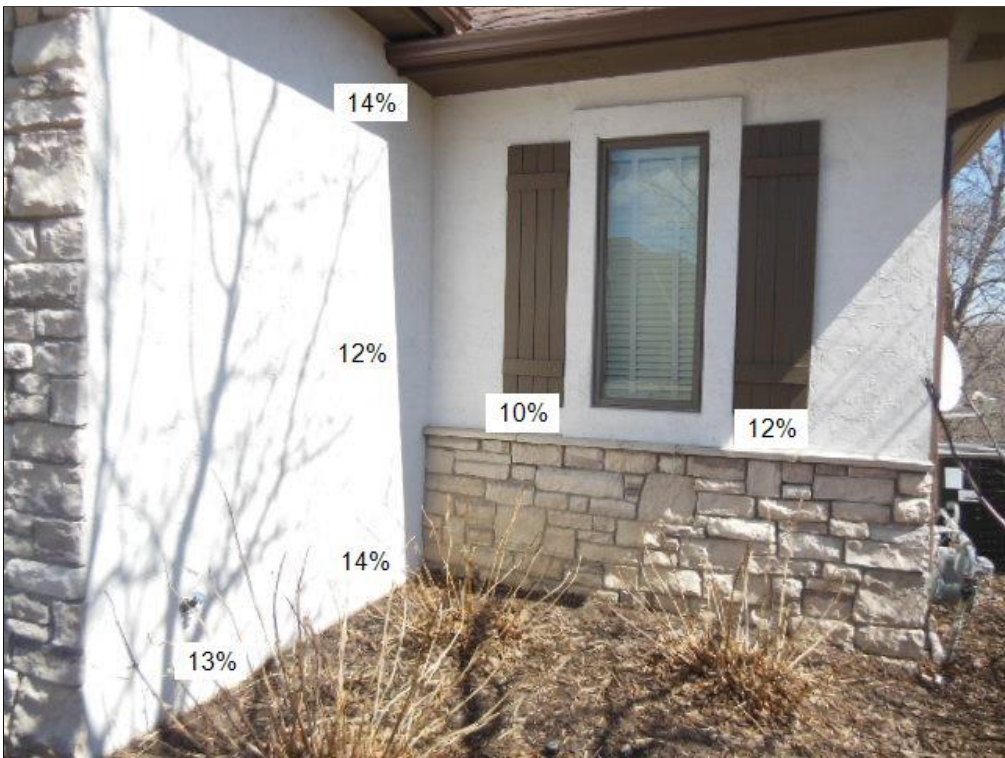
2.3 Elevation

(1) There were no elevated moisture readings, and the wall sheathing was firm at all of the areas tested below.

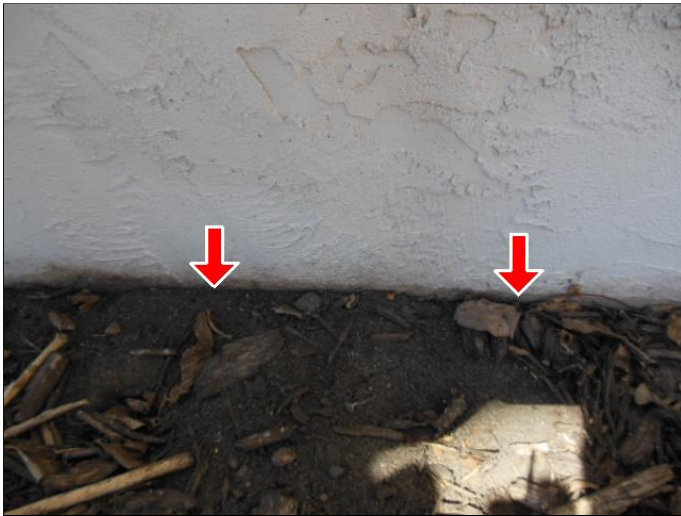
(2) The stucco is installed below grade or within six inches of grade. This can result in several problems including moisture wicking up from the soil, moisture entering the walls from above being unable to drain, and insects entering the wall from underground. Consider having the stucco trimmed to six or eight inches above grade and installing a weep screed for better drainage.

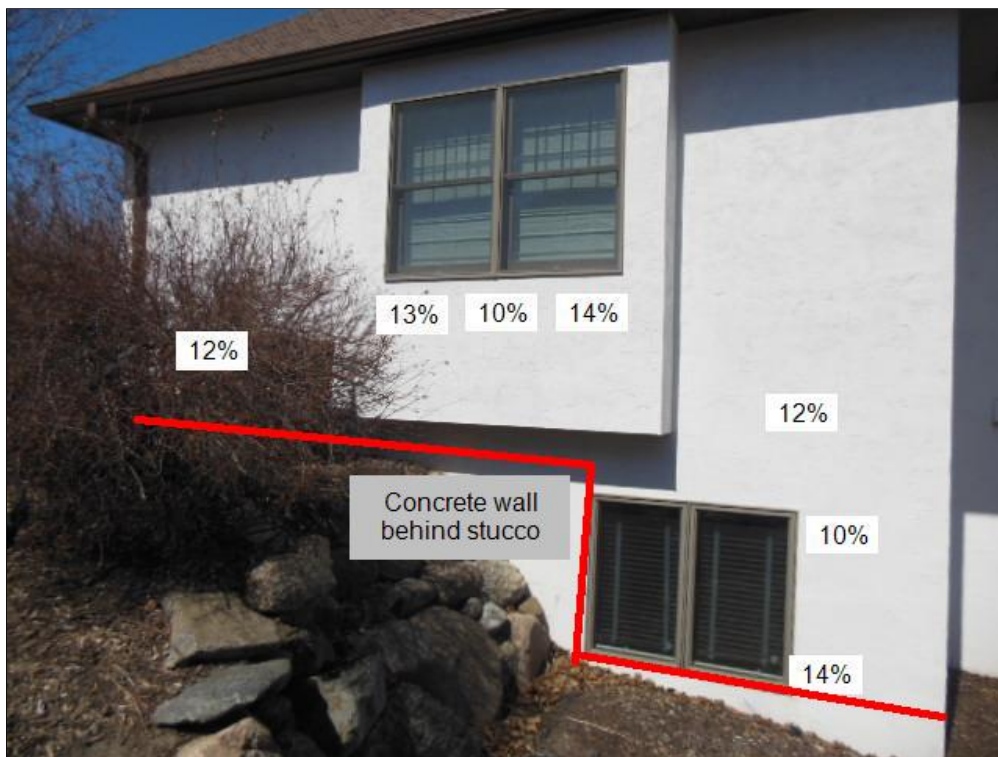
2.4 Elevation

There were no elevated moisture readings, and the wall sheathing was firm at all of the areas tested below.

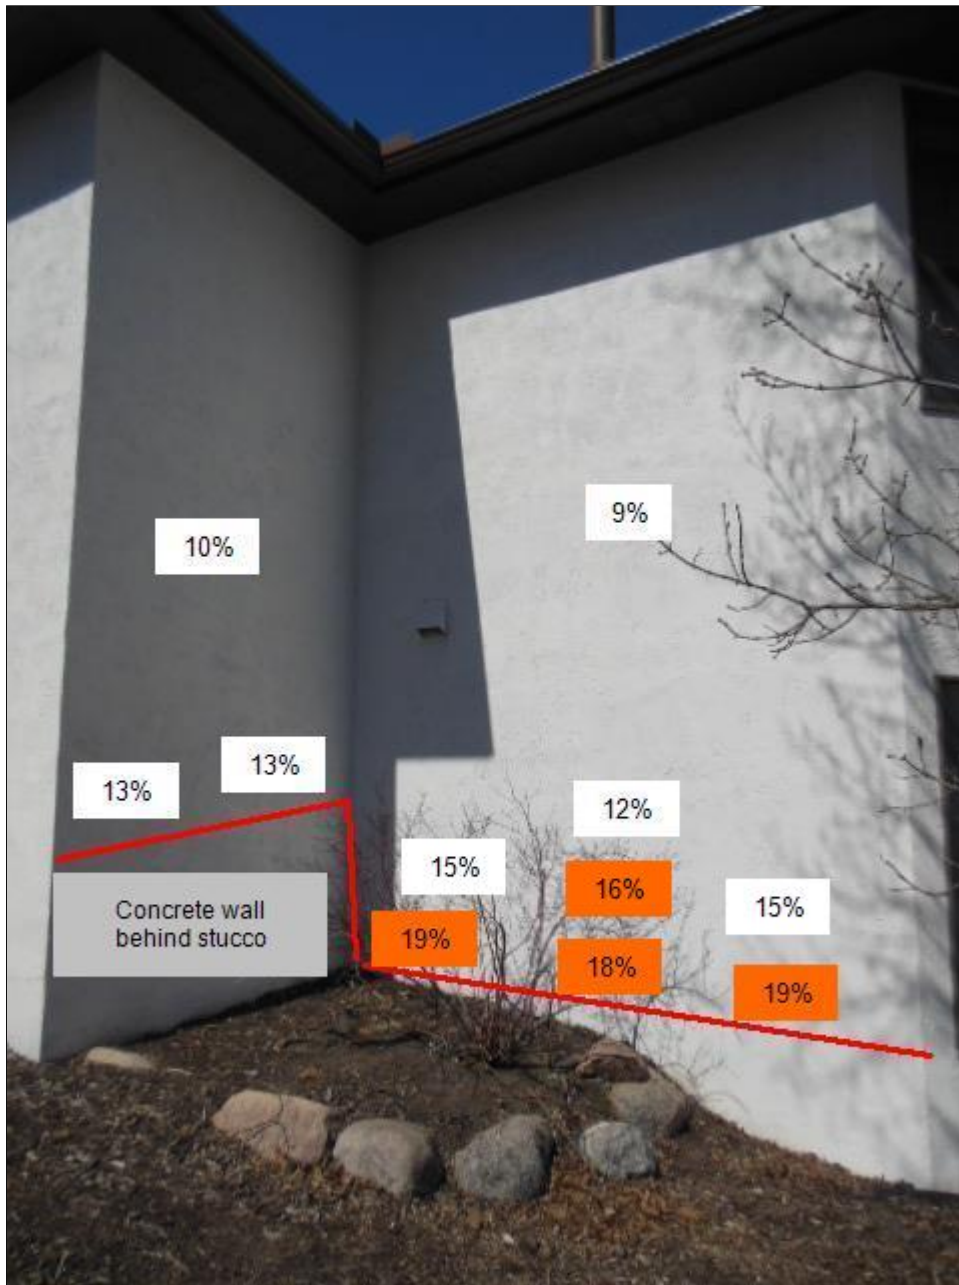
2.5 Elevation

The moisture readings in orange were between 16% and 19%, which indicates elevated moisture readings but without signs of structural damage. The cause of the elevated moisture levels should be identified and corrected. The moisture intrusion may possibly be corrected by caulking, sealing, or adding missing flashings. Have the affected areas re-tested within six months to one year.

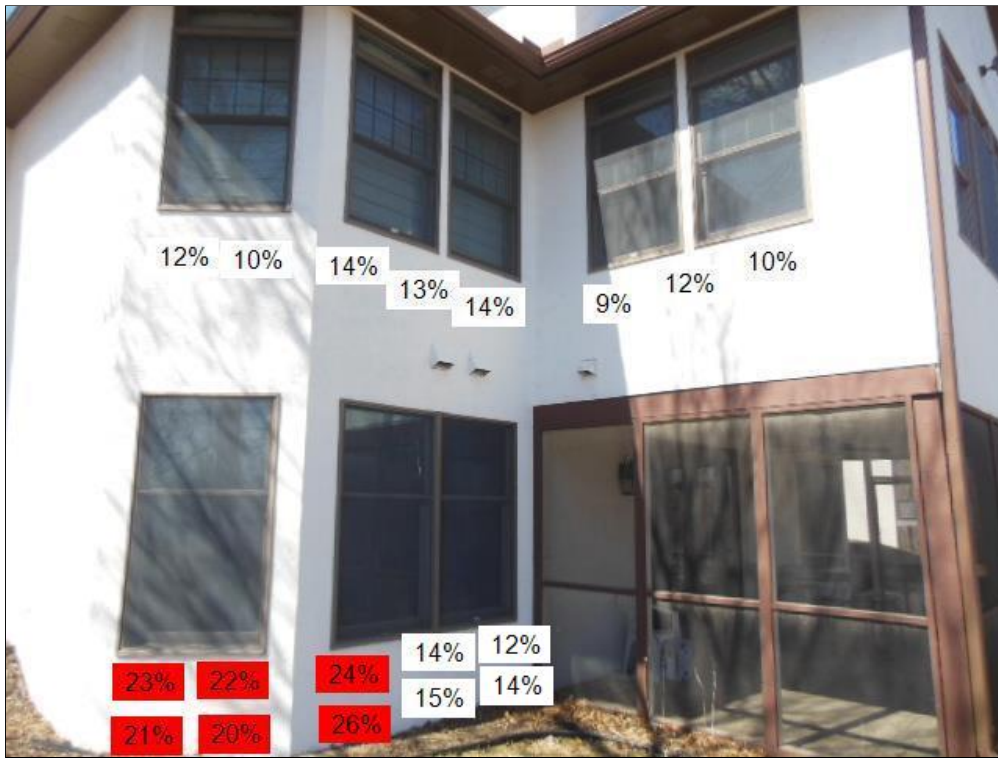
2.6 Elevation

(1) The moisture readings in red were at 20% or higher indicating active leaking and possible structural damage.

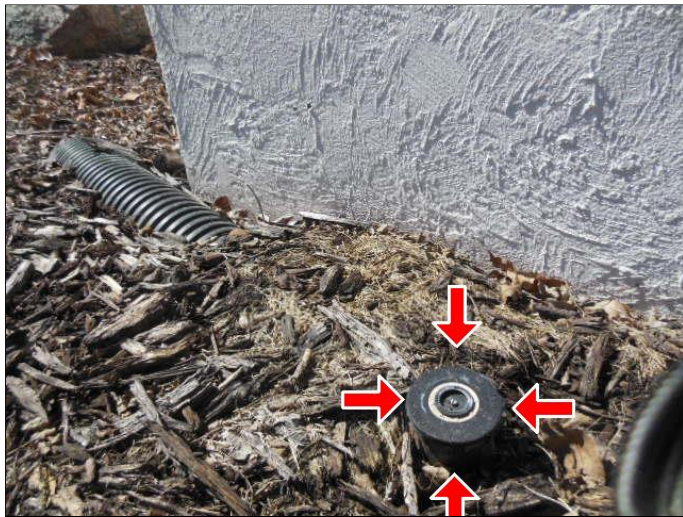
(2) Sprinklers to close to the stucco walls. Monitor or repair.

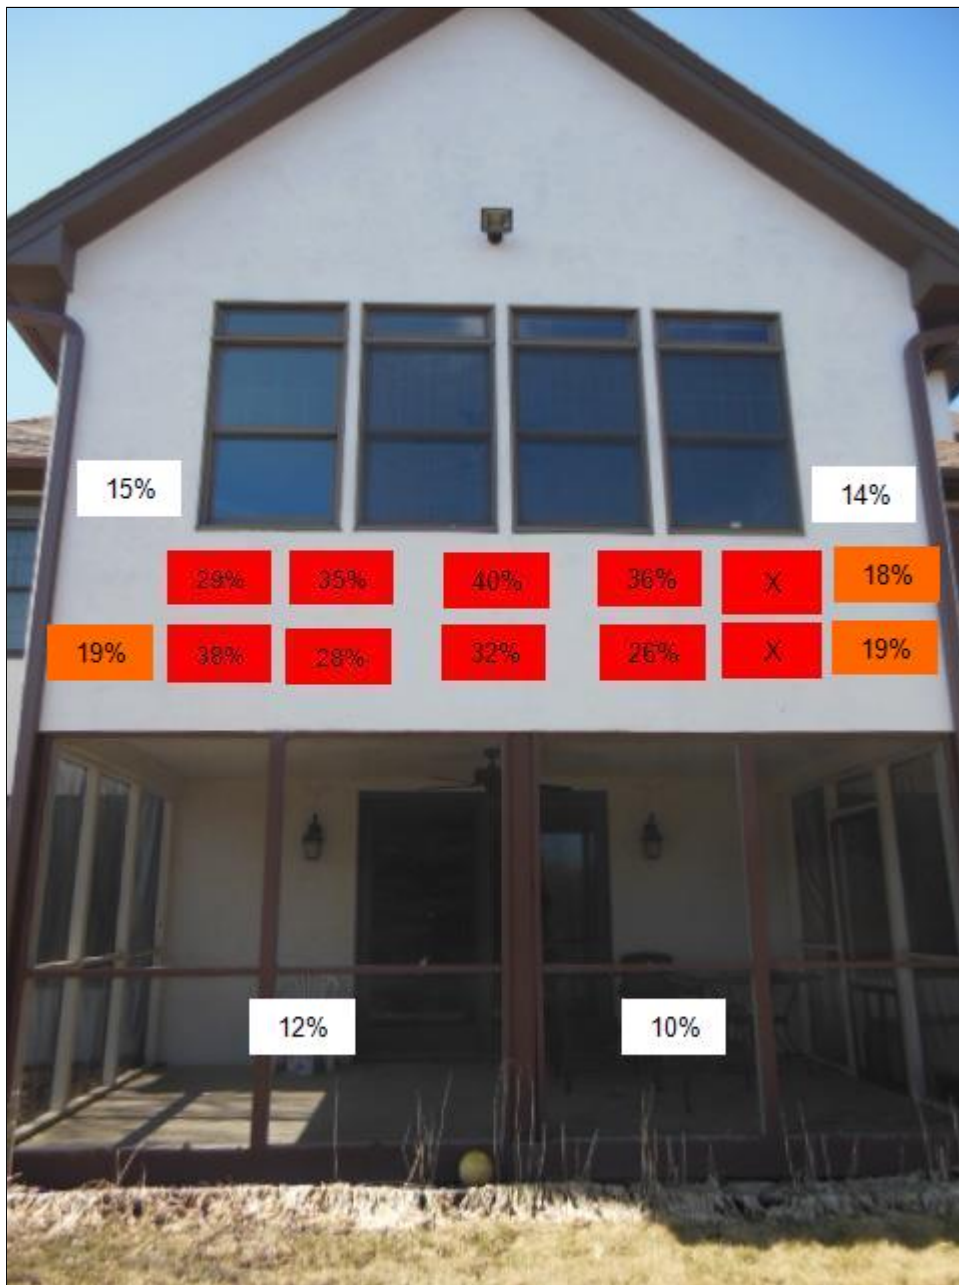
2.7 Elevation

No sheathing detected or too soft to detect on red X area. This is considered wood rot. Investigate further. The moisture readings in orange were between 16% and 19%, which indicates elevated moisture readings but without signs of structural damage. The cause of the elevated moisture levels should be identified and corrected. The moisture intrusion may possibly be corrected by caulking, sealing, or adding missing flashings. Have the affected areas re-tested within six months to one year.

The moisture readings in red were at 20% or higher indicating active leaking and possible structural damage.

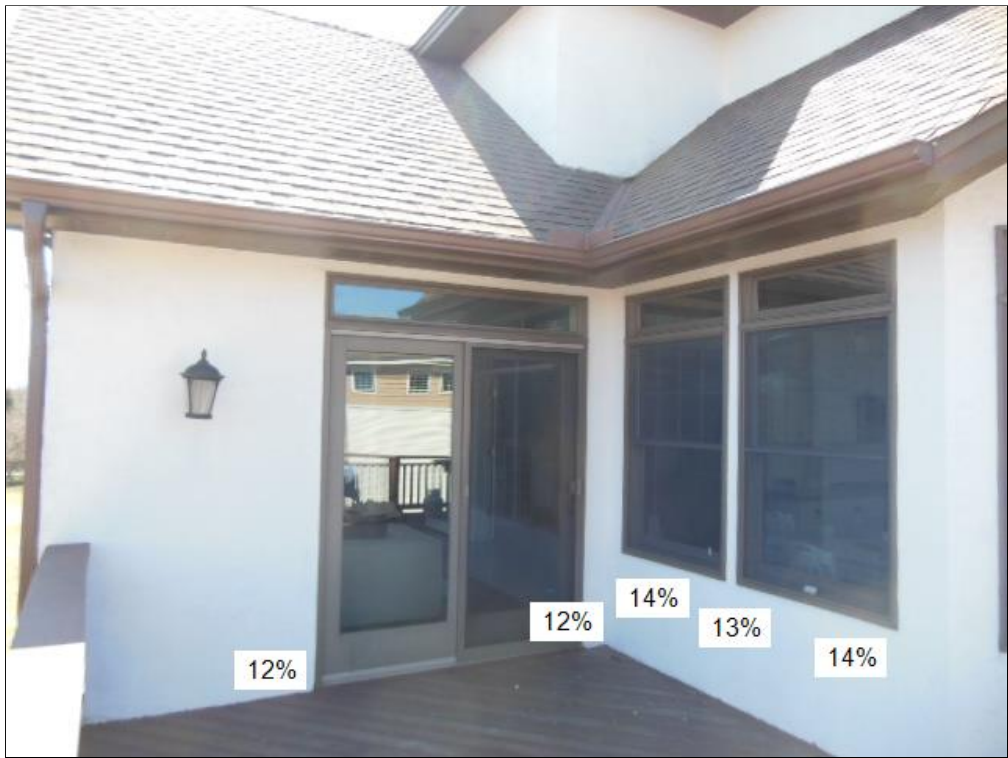
2.8 Elevation

There were no elevated moisture readings, and the wall sheathing was firm at all of the areas tested below.

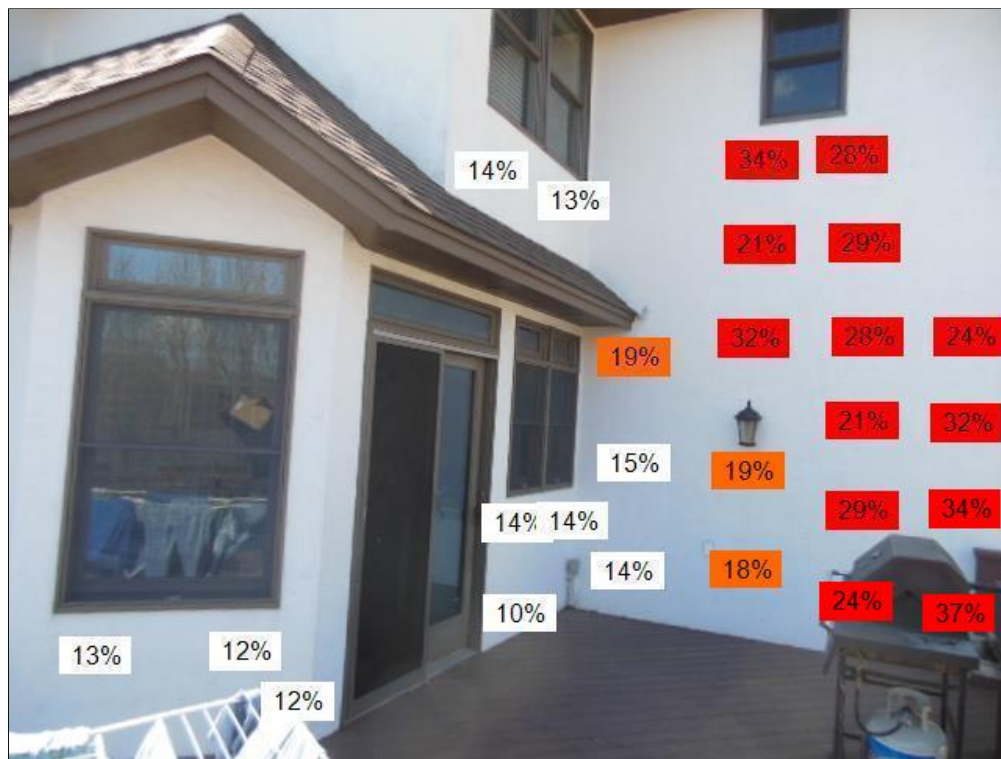
2.9 Elevation

(1) The moisture readings in red were at 20% or higher indicating active leaking and possible structural damage.

The moisture readings in orange were between 16% and 19%, which indicates elevated moisture readings but without signs of structural damage. The cause of the elevated moisture levels should be identified and corrected. The moisture intrusion may possibly be corrected by caulking, sealing, or adding missing flashings. Have the affected areas re-tested within six months to one year.

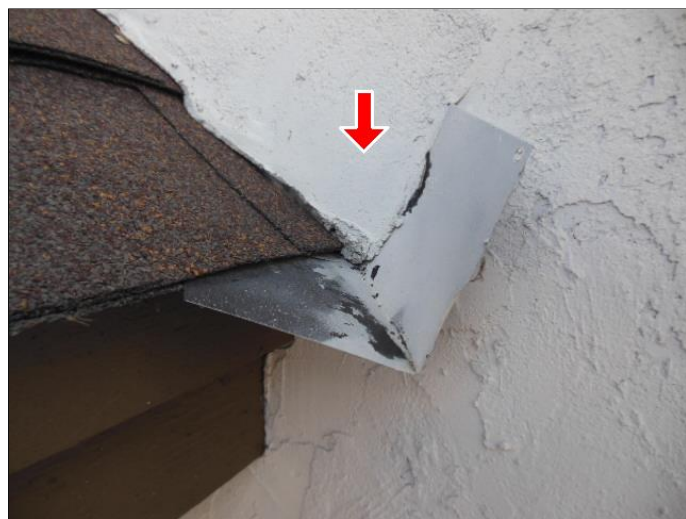
(2) Existing kickout flashings appear to be properly installed but are showing signs of high moisture intrusion. They may need to be re-installed, or if they were recently installed the affected areas may not have had adequate time to dry.

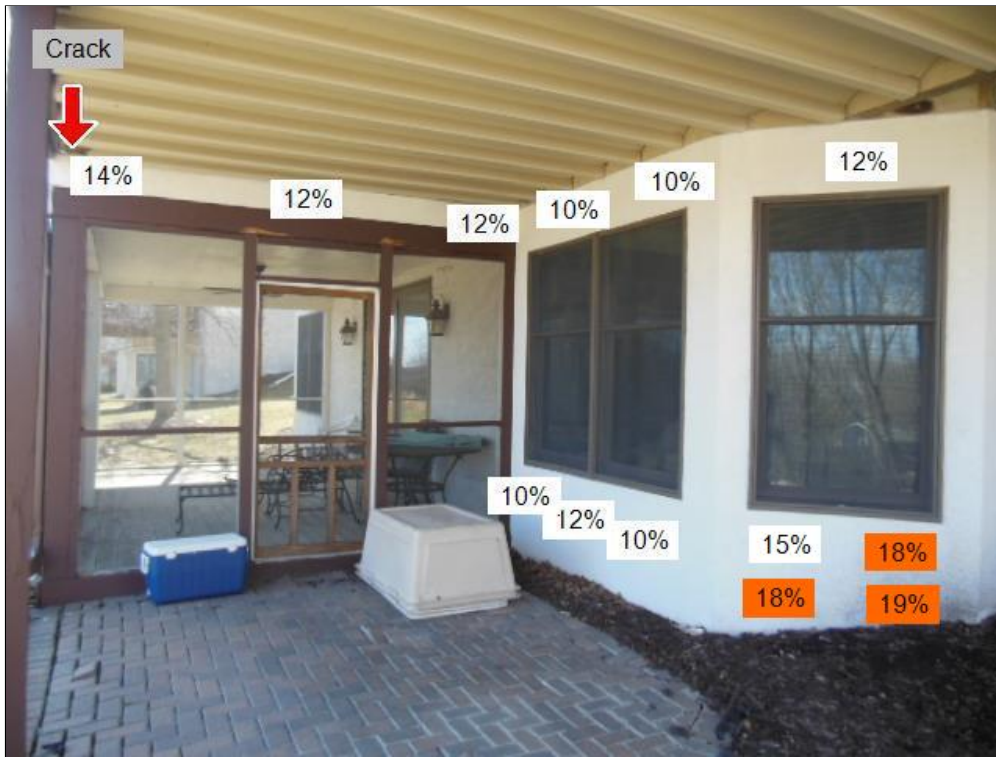
2.10 Elevation

(1) The moisture readings in orange were between 16% and 19%, which indicates elevated moisture readings but without signs of structural damage. The cause of the elevated moisture levels should be identified and corrected. The moisture intrusion may possibly be corrected by caulking, sealing, or adding missing flashings. Have the affected areas re-tested within six months to one year.

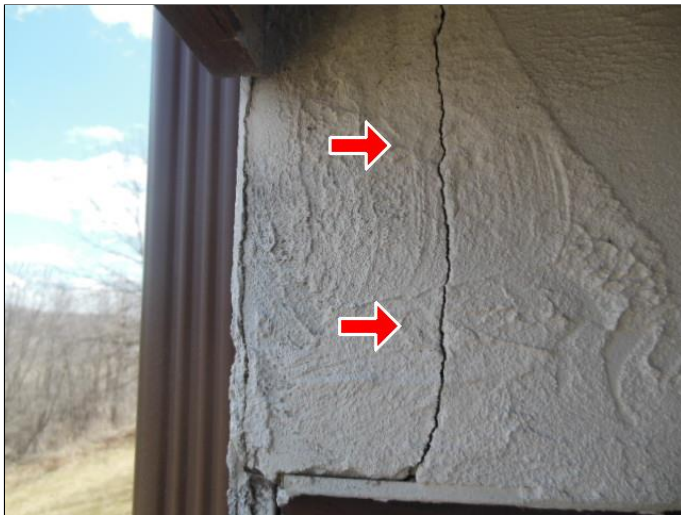
(2) Crack noted. Monitor or repair.

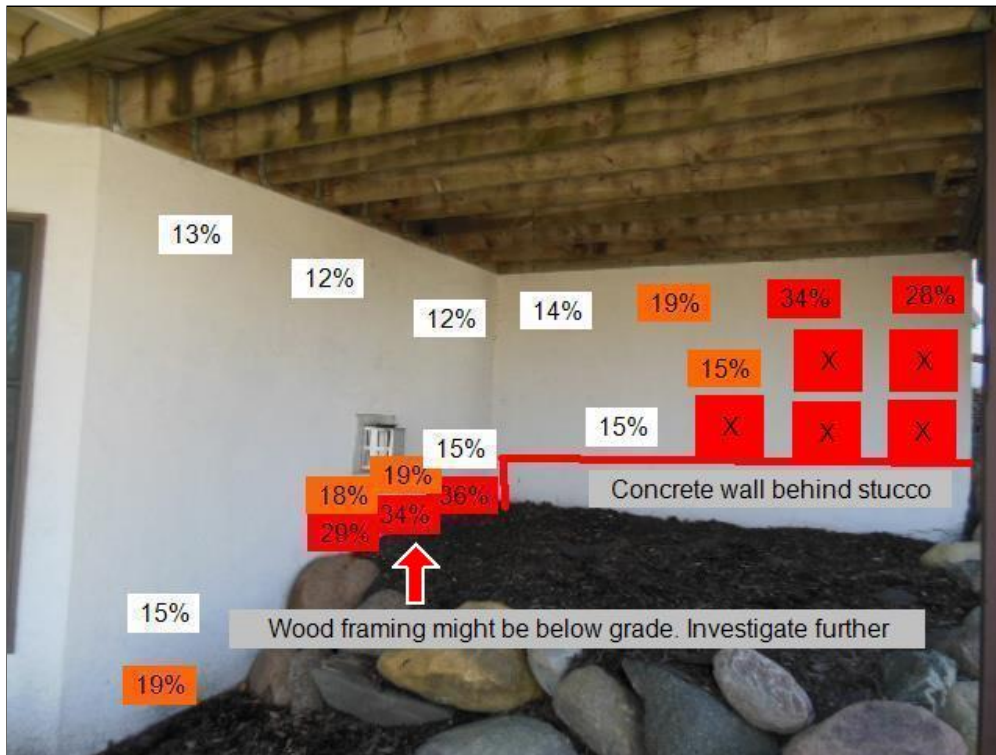
2.11 Elevation

No sheathing detected or too soft to detect on red X area. This is considered wood rot. Investigate further.

The moisture readings in orange were between 16% and 19%, which indicates elevated moisture readings but without signs of structural damage. The cause of the elevated moisture levels should be identified and corrected. The moisture intrusion may possibly be corrected by caulking, sealing, or adding missing flashings. Have the affected areas re-tested within six months to one year.

The moisture readings in red were at 20% or higher indicating active leaking and possible structural damage.

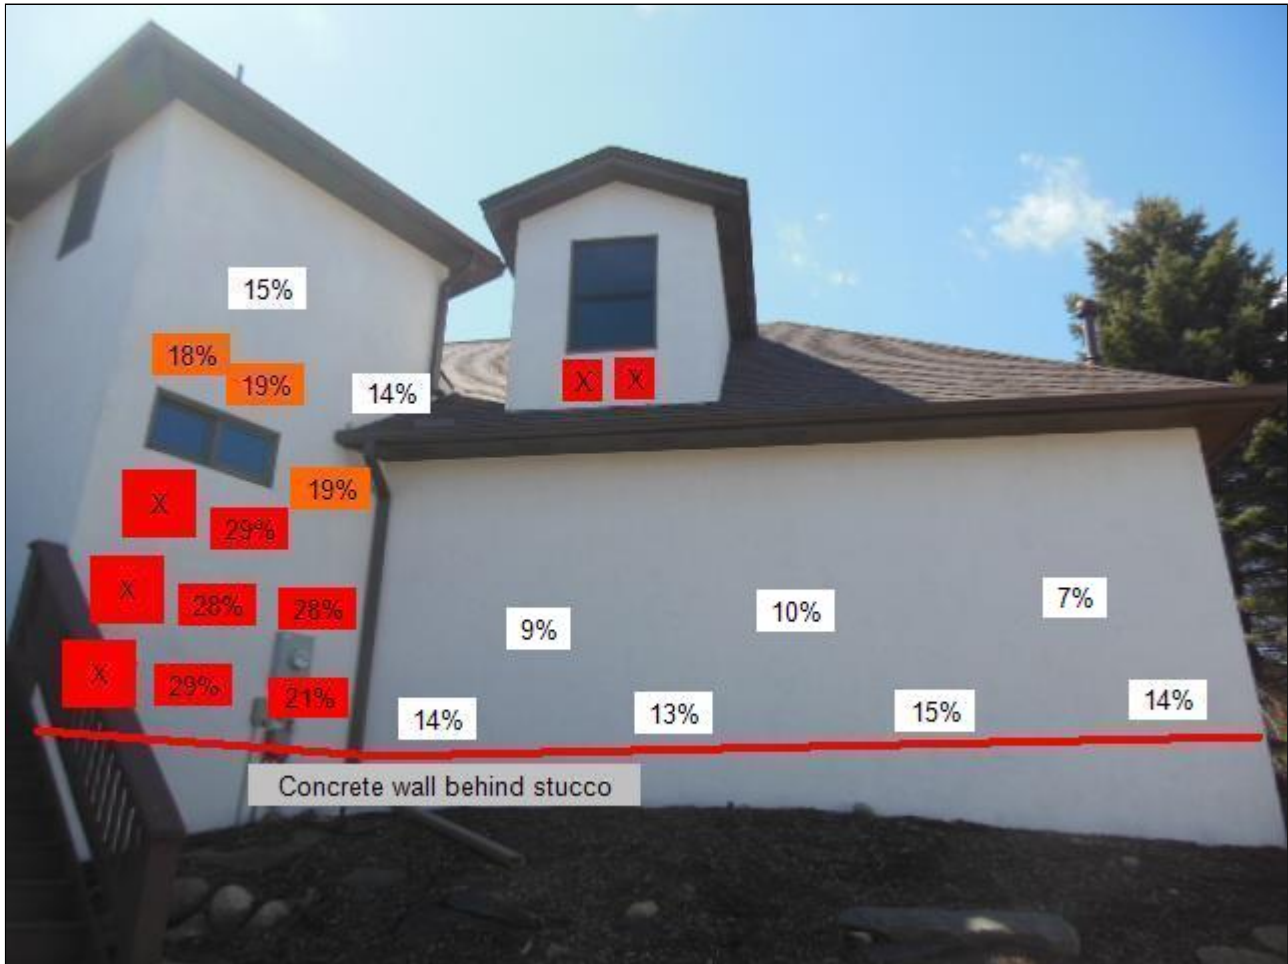
2.12 Elevation

(1) No sheathing detected or too soft to detect on red X area. This is considered wood rot. Investigate further.

The moisture readings in orange were between 16% and 19%, which indicates elevated moisture readings but without signs of structural damage. The cause of the elevated moisture levels should be identified and corrected. The moisture intrusion may possibly be corrected by caulking, sealing, or adding missing flashings. Have the affected areas re-tested within six months to one year.

The moisture readings in red were at 20% or higher indicating active leaking and possible structural damage.

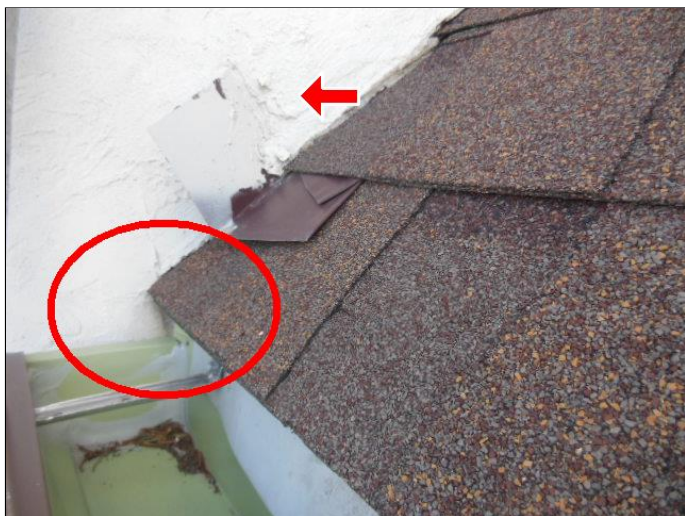
(2) Some kickout flashings were installed improperly and have the potential to allow for moisture intrusion. Have them properly re-installed.

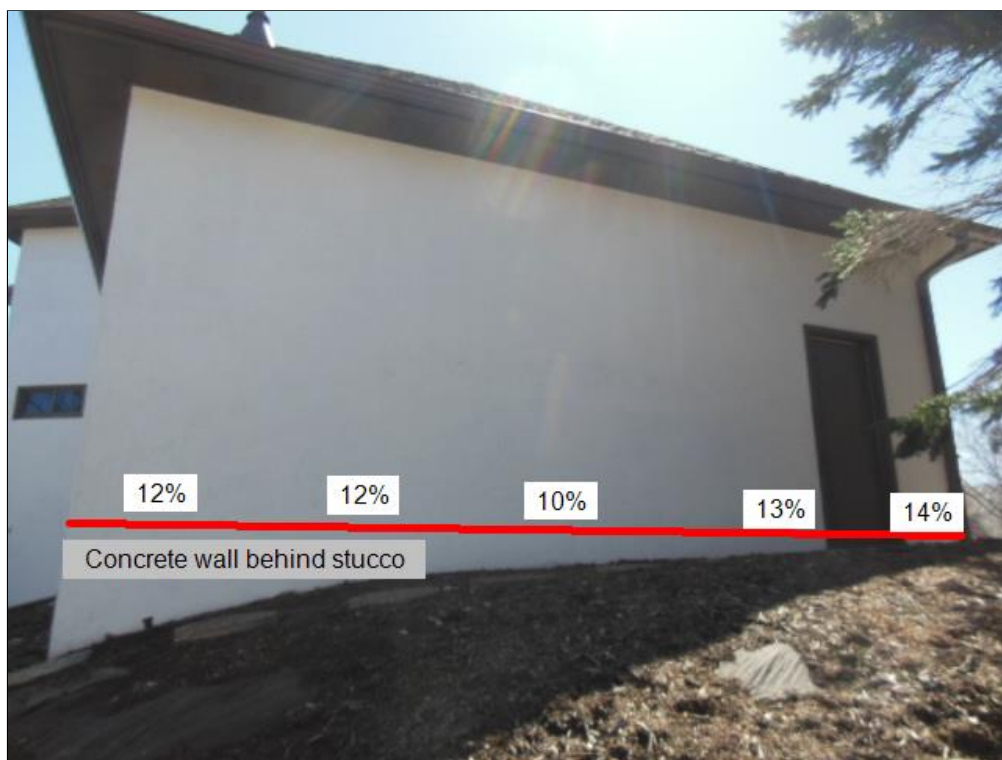
2.13 Elevation

There were no elevated moisture readings, and the wall sheathing was firm at all of the areas tested below.
