INSPECTION SERVICES

INTRUSIVE WOOD FOUNDATION INSPECTION

1234 Main st.
undefined, undefined undefined

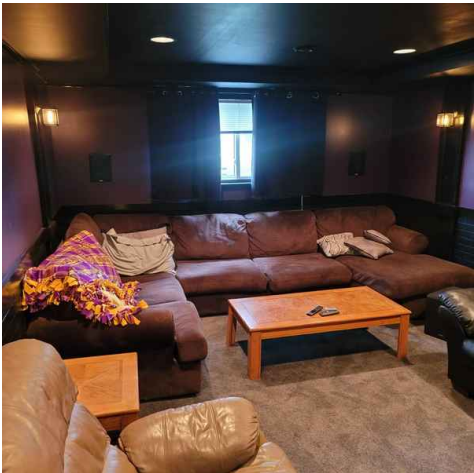
Stored items prevented a complete inspection of the basement.

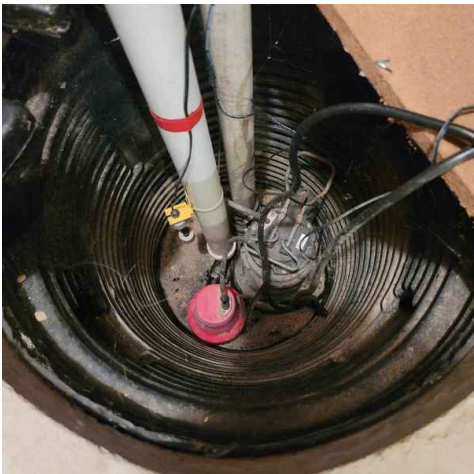
The sump basket was dry or had very little water in it at the time of the inspection, so the sump pump was not tested.

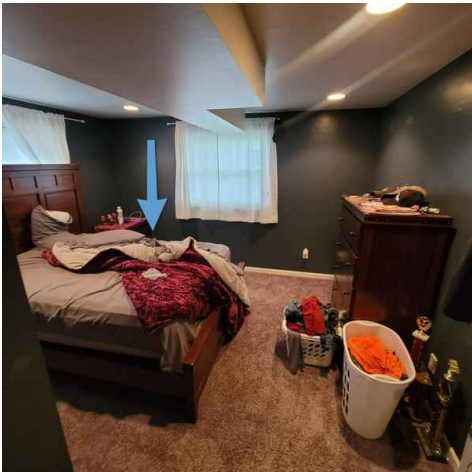
outlet - north wall - basement bedroom

Acceptable/low levels of moisture were measured at this test location.

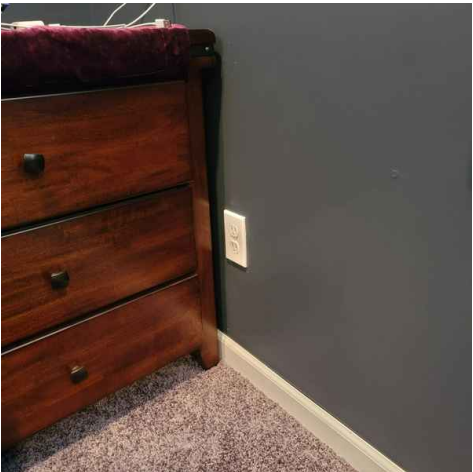
receptacle cover removed for access to foundation

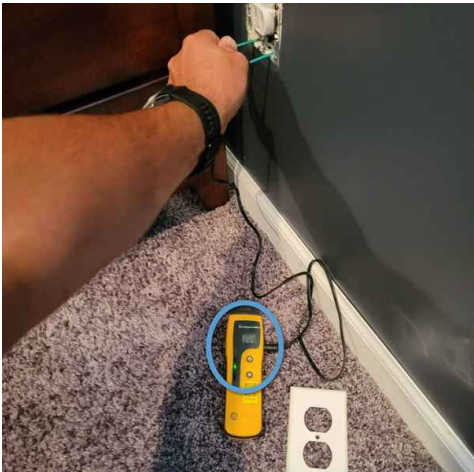
low/acceptable moisture level measured with deep wall probes

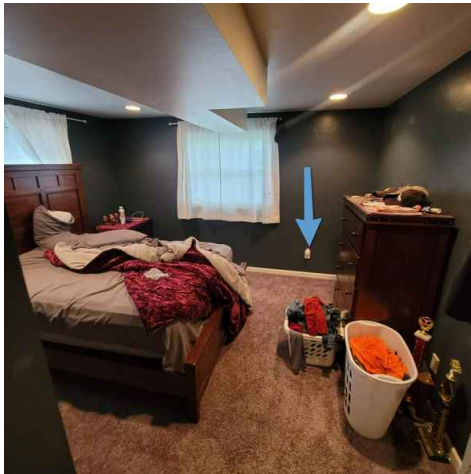
outlet - north wall - basement bedroom

Acceptable/low levels of moisture were measured at this test location.

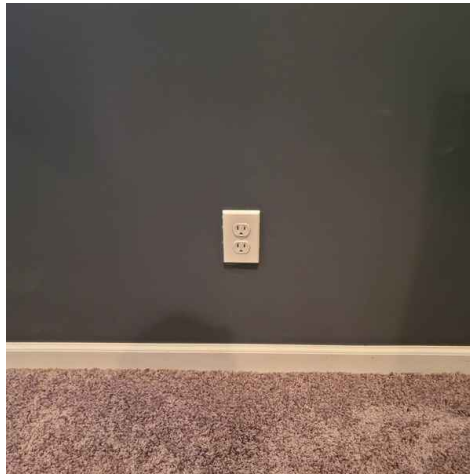
receptacle cover removed for access to foundation

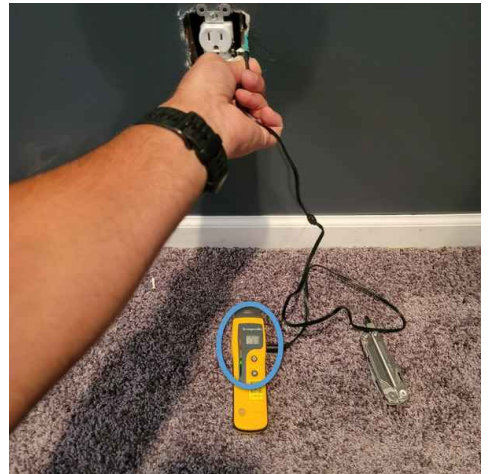
low/acceptable moisture level measured with deep wall probes

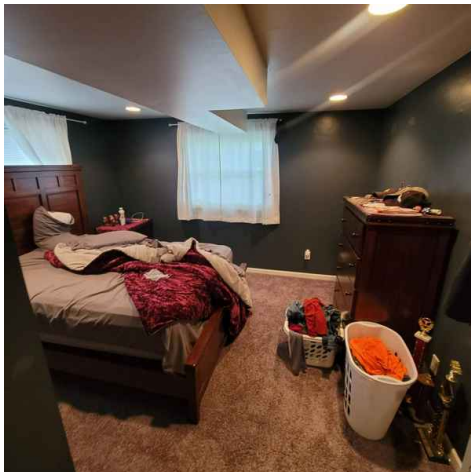
baseboard - north wall - basement bedroom

Acceptable/low levels of moisture were measured at this test location.

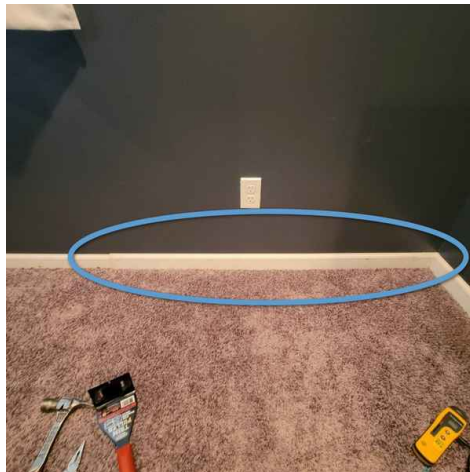
baseboard trim removed and small section of drywall cut away to view foundation

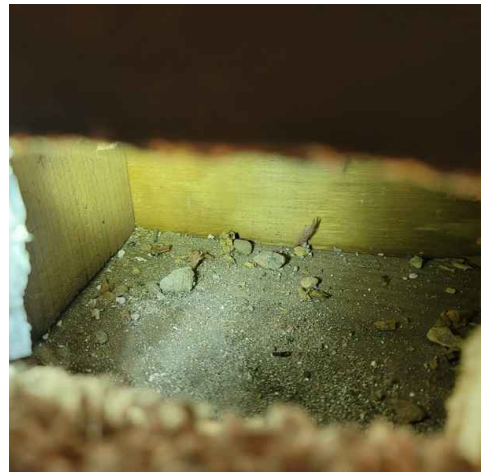
no staining/moisture witnessed at sill plate, base of stud, and treated plywood

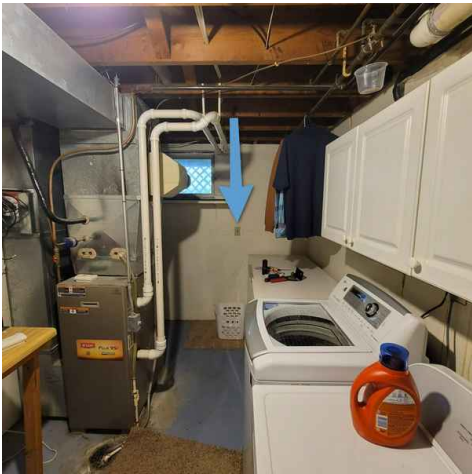
outlet - south wall - utility room

Acceptable/low levels of moisture were measured at this test location.

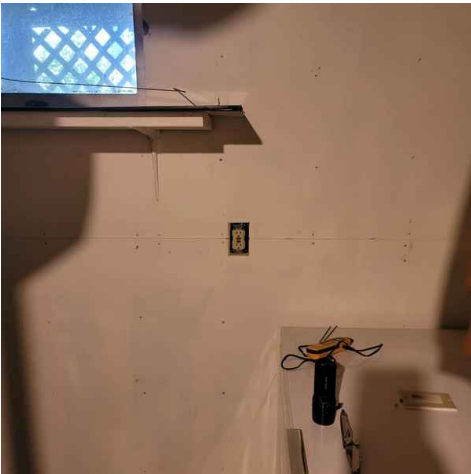
receptacle cover removed for access to foundation

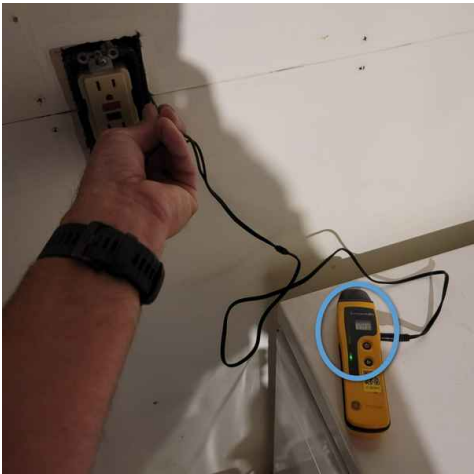
low/acceptable moisture level measured with deep wall probes

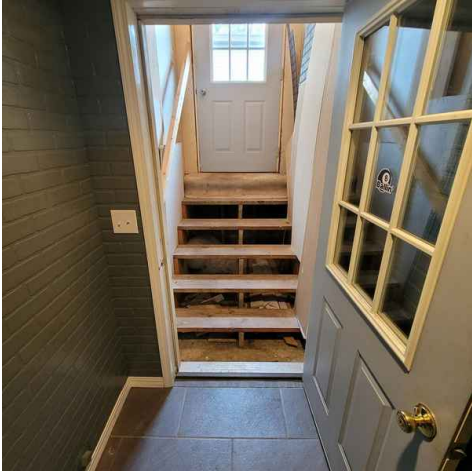
unfinished area - west wall - under basement staircase

PERMANENT WOOD FOUNDATION TEST AREA 5

Elevated levels of moisture were measured at this test location. One or more components of the water management system (grading, drainage, gutters, downspouts, sump pump, etc.) appear to have failed or were inadequate, which can lead to moisture issues at the foundation. A wet wood foundation can lead to poor indoor air quality and damaged interior finishes. Improve water management at the exterior to help prevent further damage to the foundation wall.

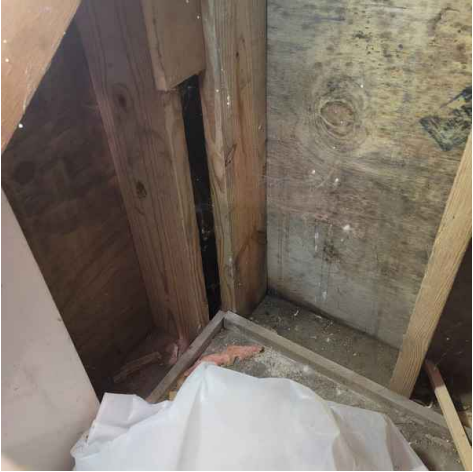
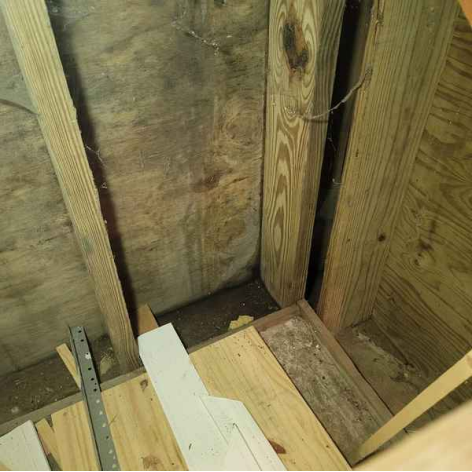
staining and signs of moisture witnessed

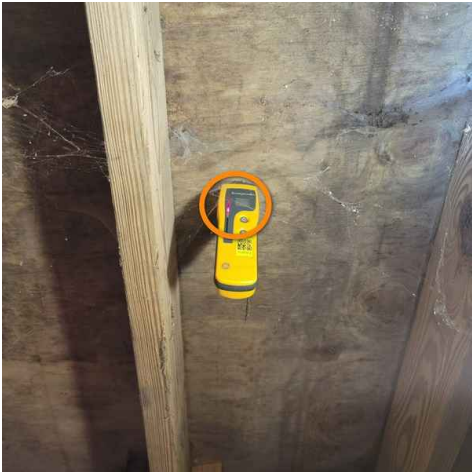
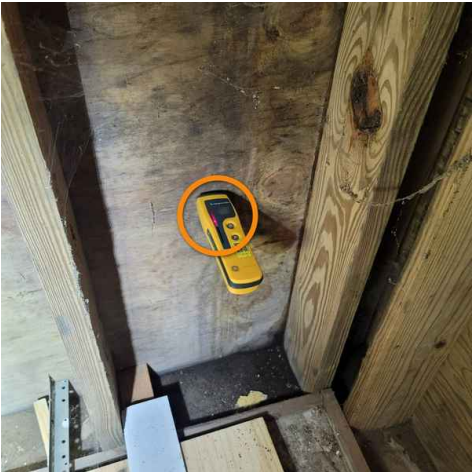
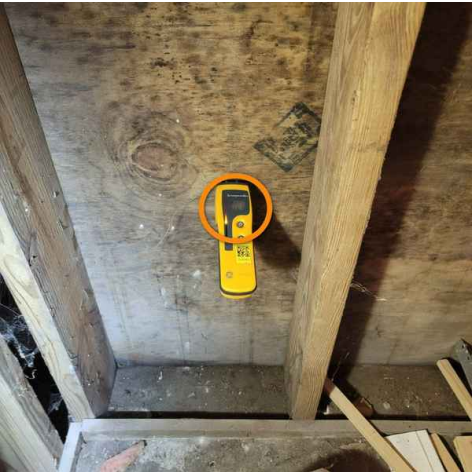
elevated moisture level

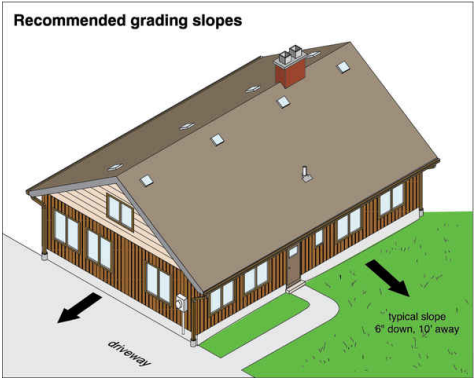
GRADING - FLAT

The ground was flat in areas next to the building, which could allow water to enter the basement or cause excessive soil pressures against the foundation walls. The soil or hard surfaces should slope away from the house for at least ten feet to help prevent basement water intrusion and foundation problems.

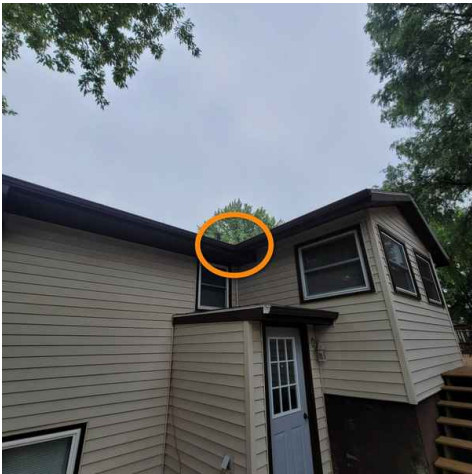
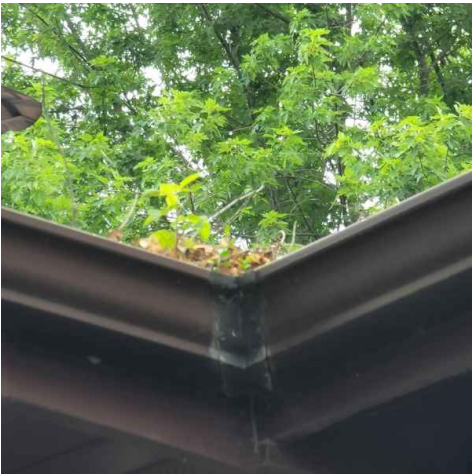
DEBRIS/LEAVES IN GUTTERS

The gutters were filled with leaves/debris and should be cleaned in order to drain properly.

debris in gutters will prevent proper drainage

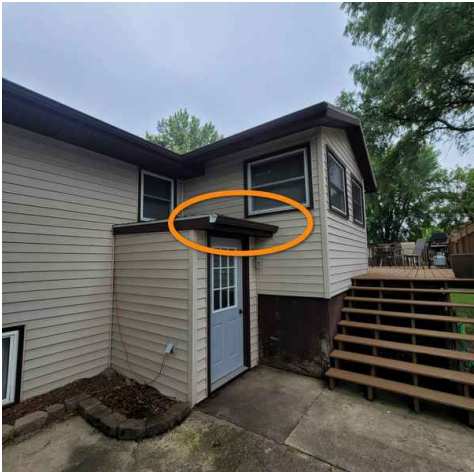
DOWNSPOUTS - MISSING

There was a missing downspout at the gutter. Have a downspout and proper extension installed to help prevent water from draining down the side of the building and causing water damage.

missing downspout allows water to spill next to the foundation - evidence of moisture at wood foundation noted at this area

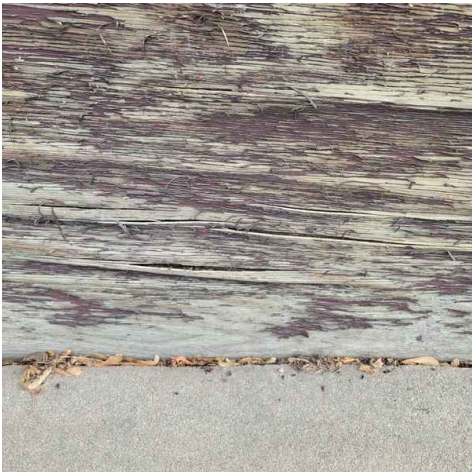
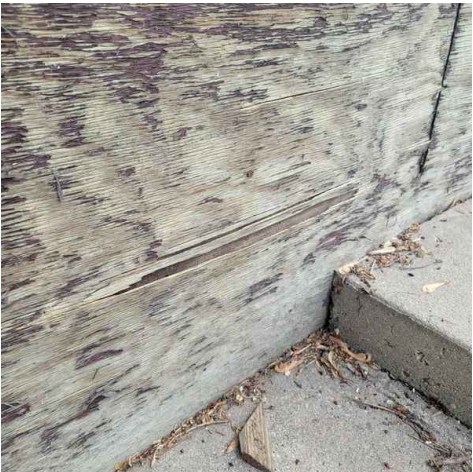
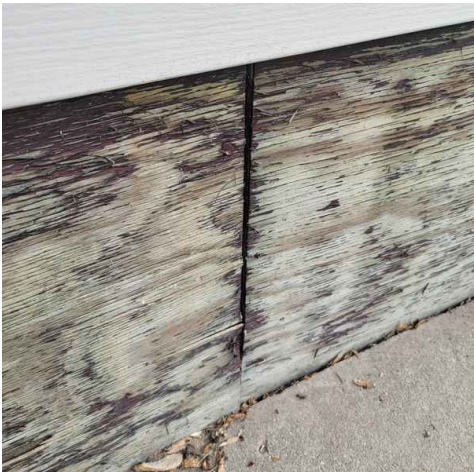
FOUNDATION DETERIORATED/DAMAGED

The exposed portion of the wood foundation at the garage was deteriorated in areas. Work with a wood foundation specialist to repair or replace these areas to help prevent further deterioration.

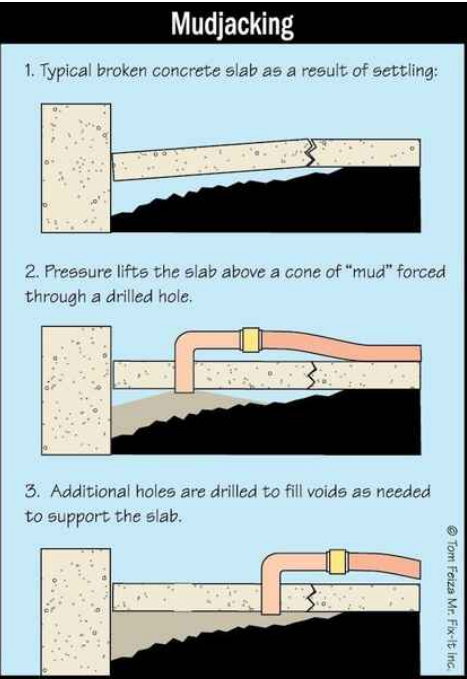
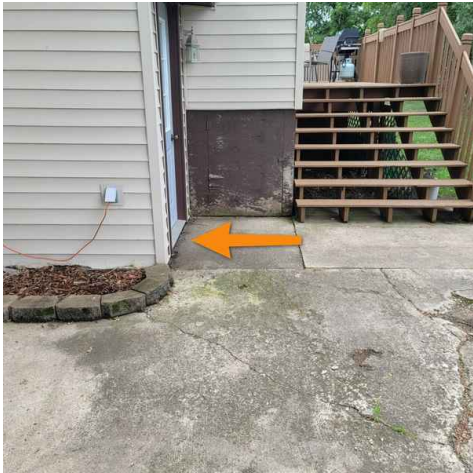
SLOPES TOWARD STRUCTURE

The patio slopes toward the structure, which can lead to basement water intrusion and damage to the foundation wall. Have the slope corrected at the patio. Two common methods of leveling concrete are sandjacking and mudjacking.
