## CHIMNEY INSPECTION

1234 Anystreet  
St. Paul, MN 55106

John Smith  
JUNE 1, 2022

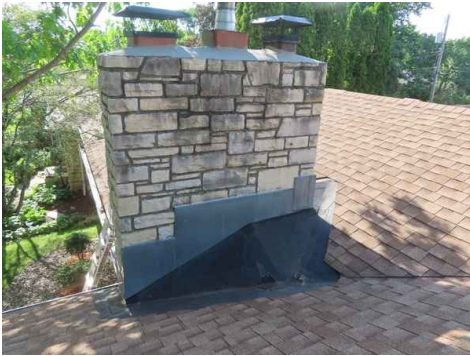
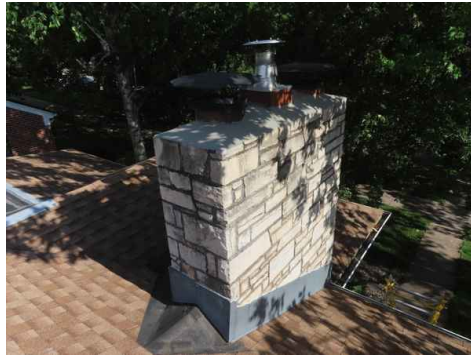
#### 2.1.1 Chimney Walls

##### **ACCEPTABLE**

The chimney walls were in acceptable condition.

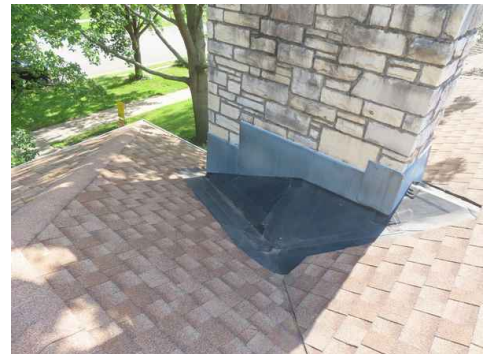
#### 2.1.2 Chimney Walls

##### **CHIMNEY LOCATED IN ROOF VALLEY**

The chimney was located in a roof valley. This is not an ideal location due to water being directed at chimney walls on a constant basis. The flashing, which directs water away from the chimney, was correctly installed. This area is prone to debris build up which could hold moisture against the chimney and possibly cause leaks. Make sure this area is cleaned of debris on a regular basis.

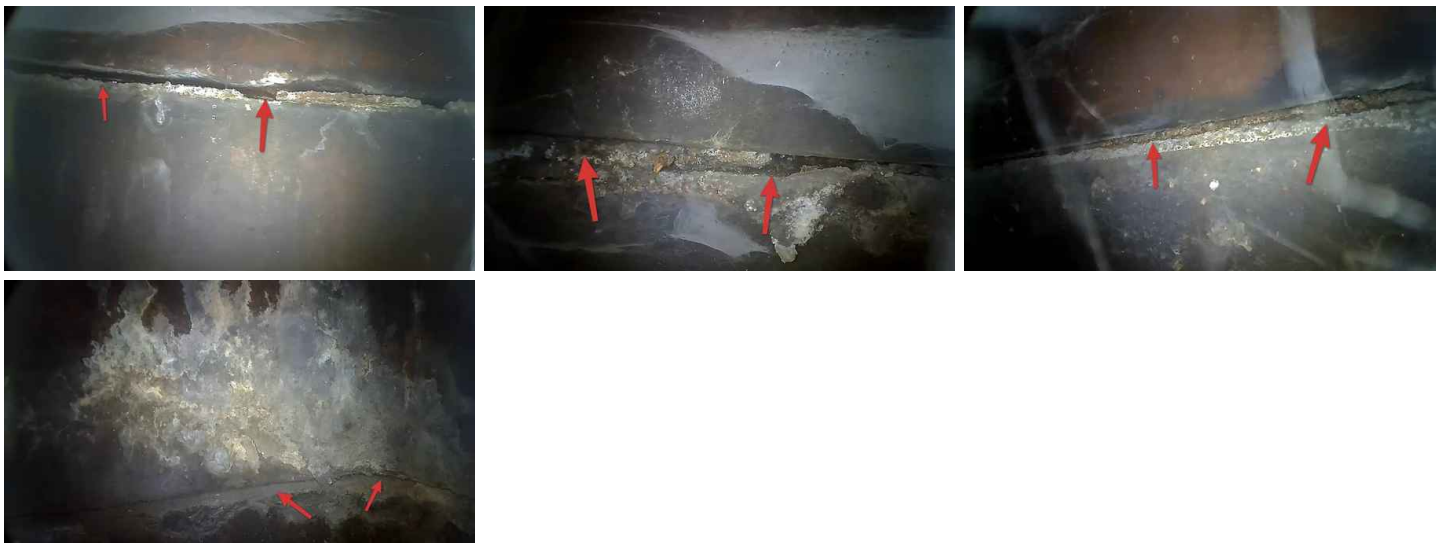
## 3.1.1 Basement

Critical/Important**FLUE JOINTS - DETERIORATED**

There was missing mortar in the joints of the clay flue liner. Without mortar in these joints, hot gases could enter between the clay sections and lead to a chimney fire. Have the chimney repaired by a CSIA Certified Chimney Sweep before using the fireplace.

This is a violation of the 2019 NFPA, Chapter 14.9: "If the flue liner in a chimney has softened, cracked, or otherwise deteriorated so that it no longer has the continued ability to contain the products of combustion (i.e., heat, moisture, creosote, and flue gases), the liner shall be either removed and replaced, repaired, or relined with a listed liner system or other approved material that will resist corrosion, softening, or cracking from flue gases at temperatures appropriate to the class of chimney service."

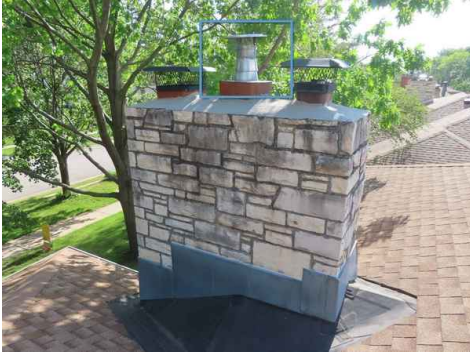
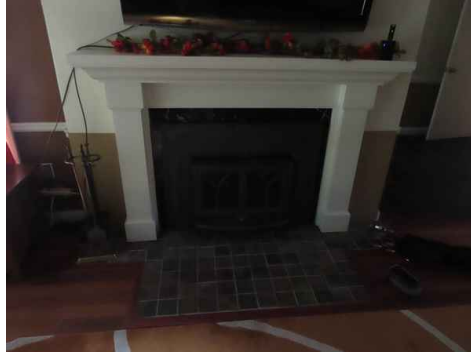
## 3.2.1 Living Room

**STEEL LINER**

The living room fireplace was installed with a flue liner. This could not be accessed at the time of inspection. This appeared to be a professional installation. Ask the homeowner for documentation about the installation.

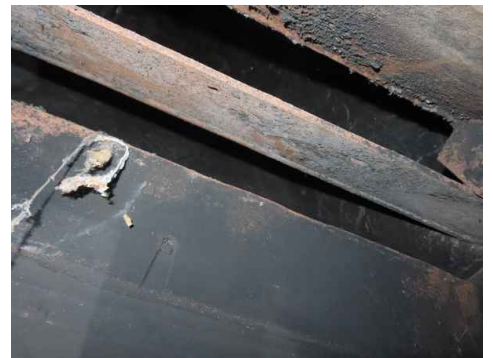
4.2.1 Firebox & Smoke Chamber

### **DAMPER DIFFICULT TO OPERATE**

The damper in the chimney was difficult to operate and should be serviced.

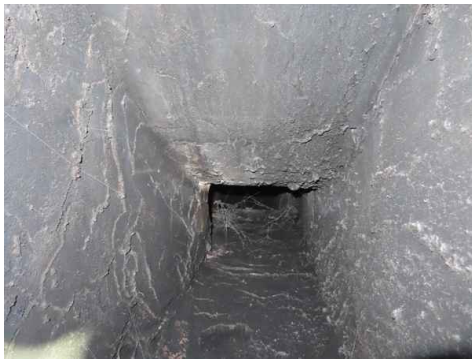
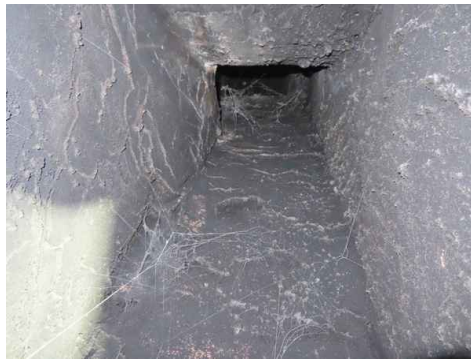
4.2.2 Firebox & Smoke Chamber

### **SMOKE CHAMBER**

The smoke chamber was in acceptable condition.
